Final Report

STUDY OF BREAK-AWAY SIGN BASE CONNECTIONS, II

State Job No. 99700-3593-119

Florida Institute of Technology

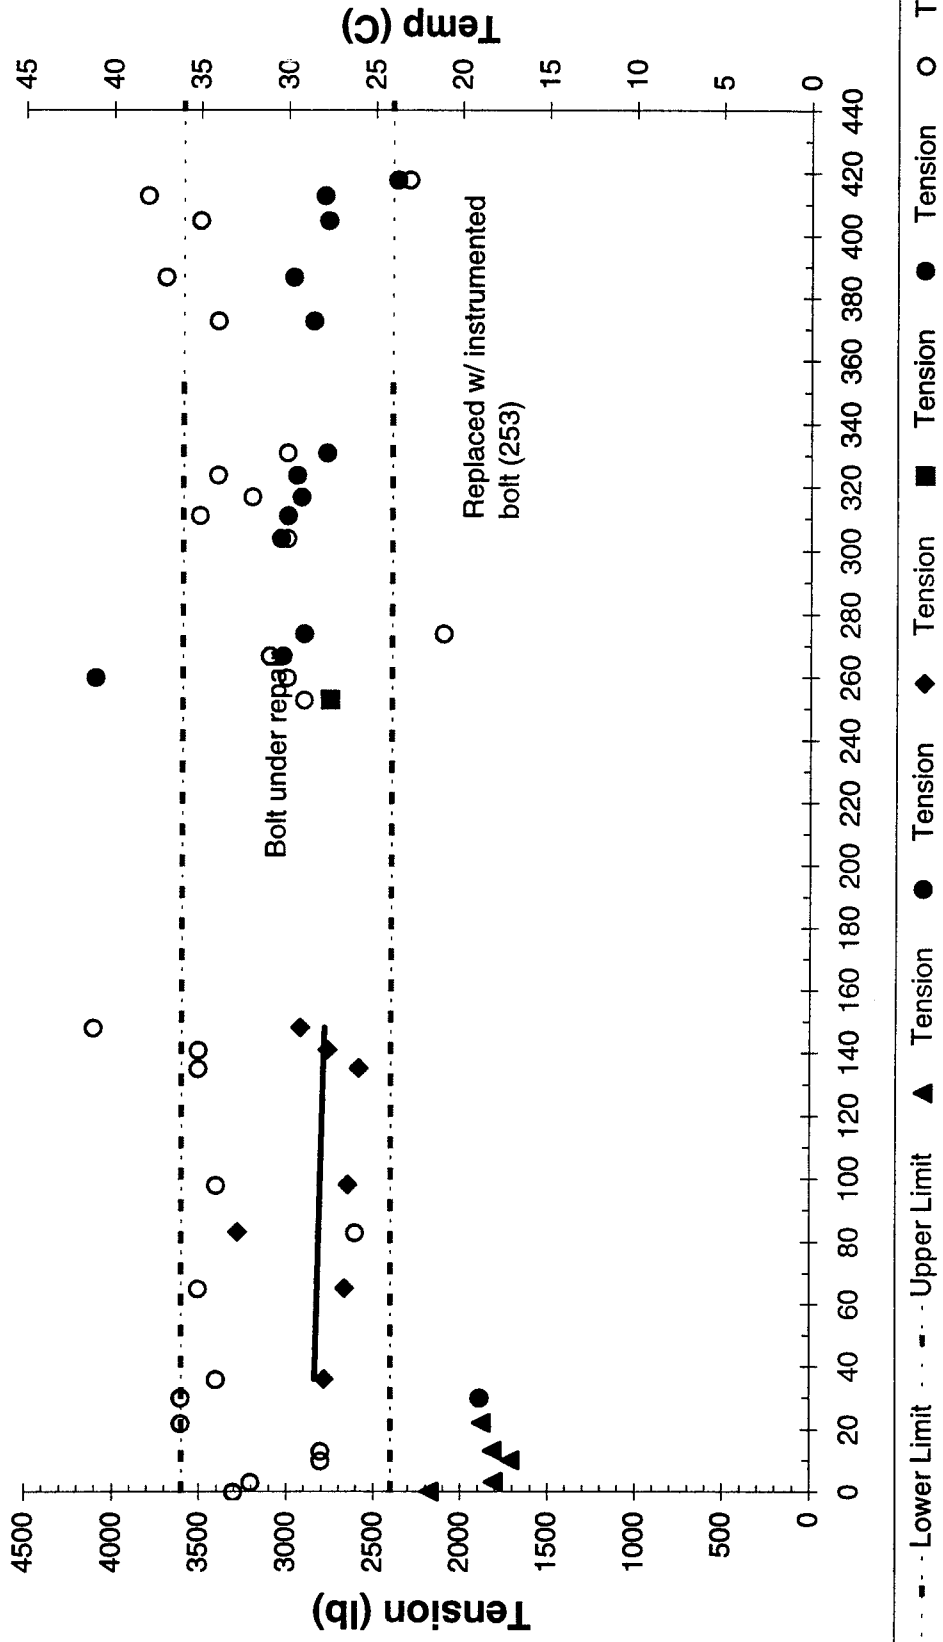
Figure 27 Tension vs Time, Tampa Sign, Bolt with Spring Washers

After the initial installation, the bolt with spring washers show readings were below the lower limit of 2400 lb. The right gage readings also registered negative strains. We suspected a

defective spring washer stack so the bolt was re-torqued on June 10 with a new spring washer stack.

The left wire was cut from the bolt head on October 23. The bolt was not replaced until February 2, 1999. One of the reasons why the bolt was not replaced for almost two months was that a FDOT crew was needed to assist in lifting the sign off the base. We also decided to focus on the other signs' bolts because most of them were damaged at that time.

The bolt was replaced on February 2, 1999 and the reading that day was in the acceptable range at 2755 lb. The reading increased to 4093 lb. the week after, on February 8. To date, the readings have kept within the acceptable range.

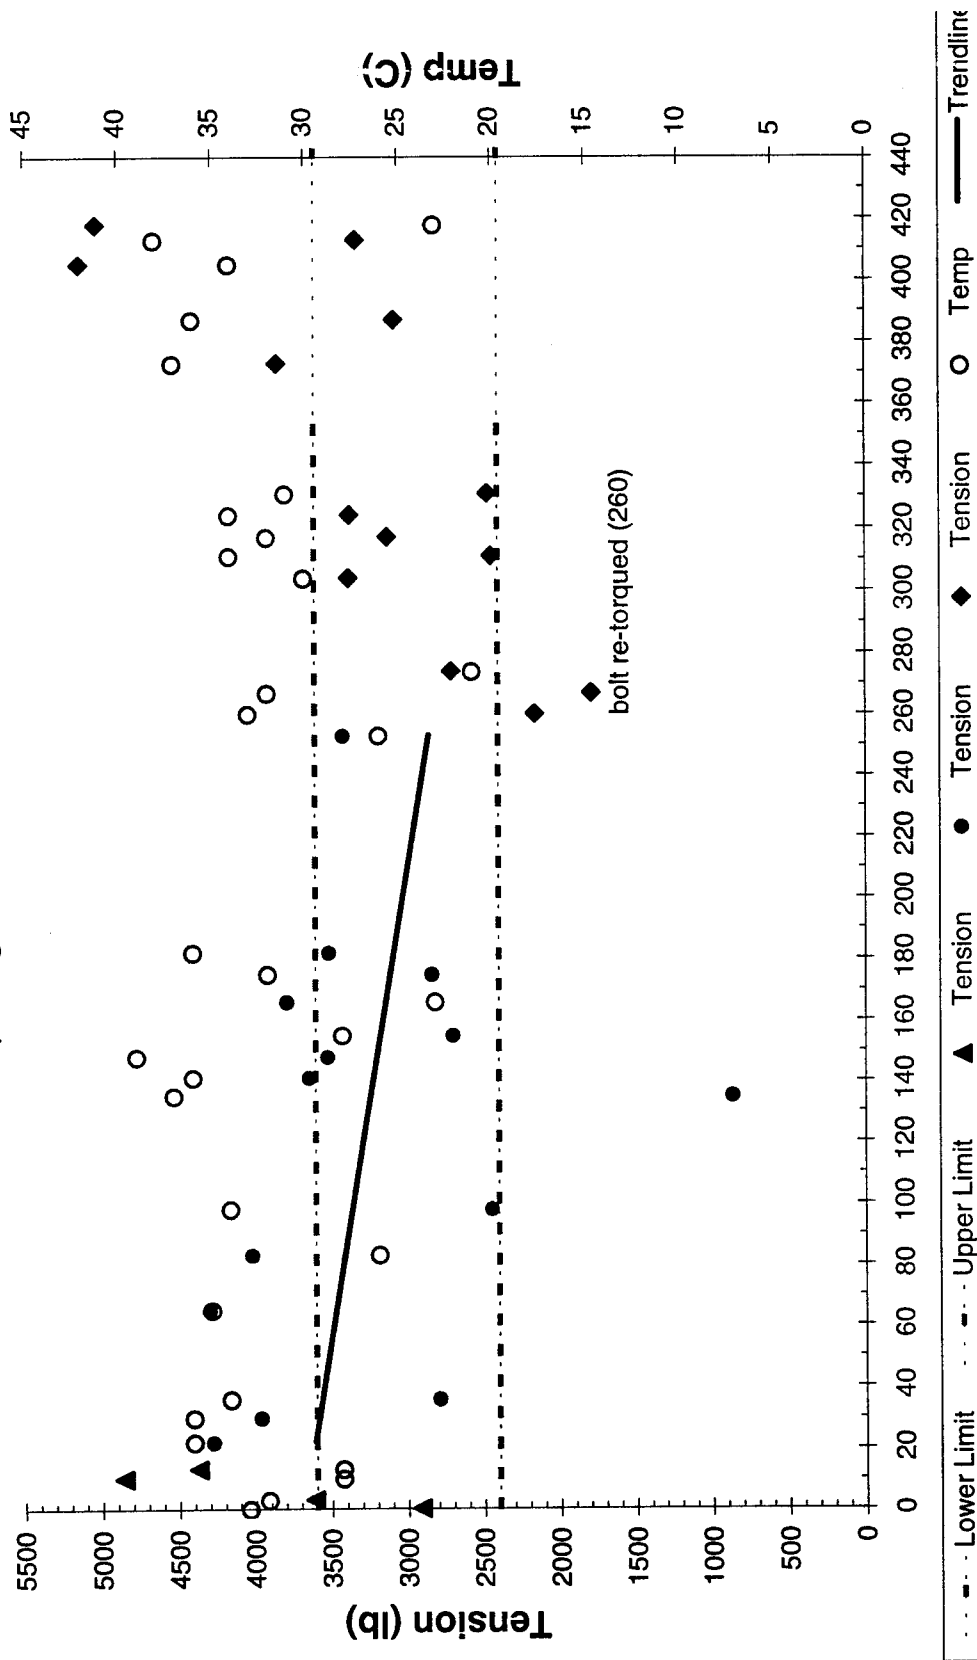
Figure 28 Tension vs Time, Tampa Sign, Bolt with Flat Washers

The bolt with flat washers was also installed on May 18, 1998. The tension readings on that day and on May 21 were 2915 lb. and 3613 lb. respectively. The tension readings increased to 4856 lb. and 4375 lb. on May 28 and June 1. The bolt was brought back to the lab to be re-tested and was re-installed on June 10. From June 18, 1998 to July 3, 1999 the tension readings were mostly in the acceptable range. The reading on October 3, 1998 was 865 lb. but this unusual reading was performed by a new research assistant and it could be disregarded. At the end of July, the gage was probably damaged and behaved erratically.

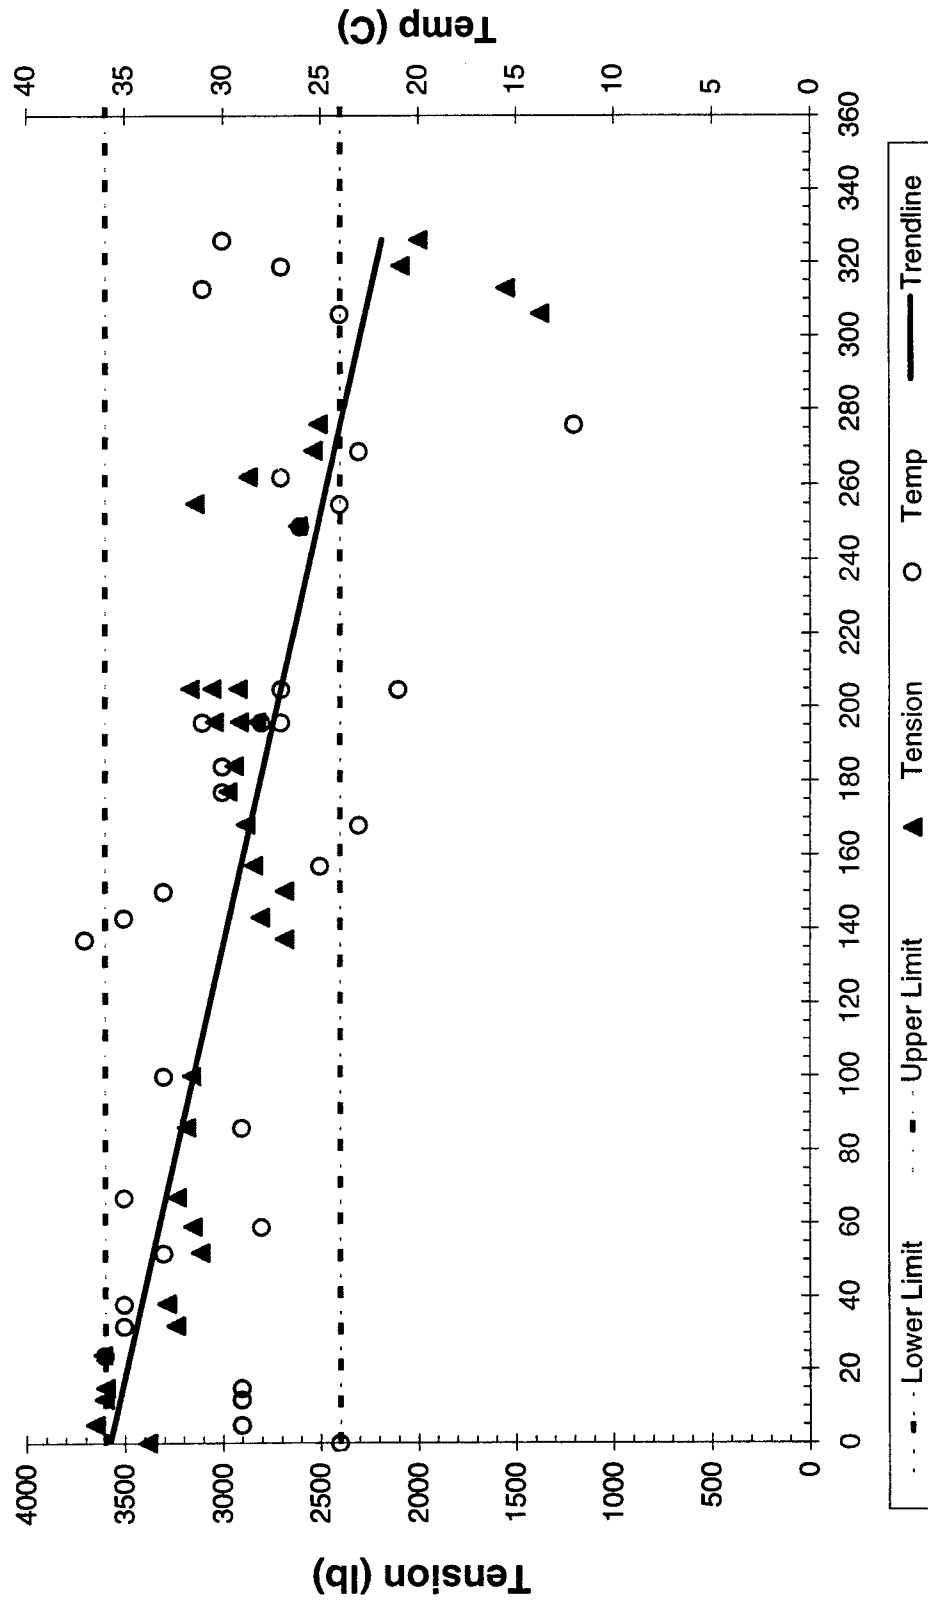
Days
Figure 30 Tension vs Time, Orlando Sign, Bolt with Spring Washers

The bolt with strain gages was never replaced and the bolt was re-torqued. The spring washers were able to keep the tension within the acceptable range from May 16, 1998 to February 22, 1999. After that date, the readings were below the allowable range. On April 12, the bolt was removed. A tensile test in the lab yielded a value of 27,117 ksi for the modulus of elasticity, slightly below the expected value of 29,000 ksi, which might indicate a deterioration of the strain gage.

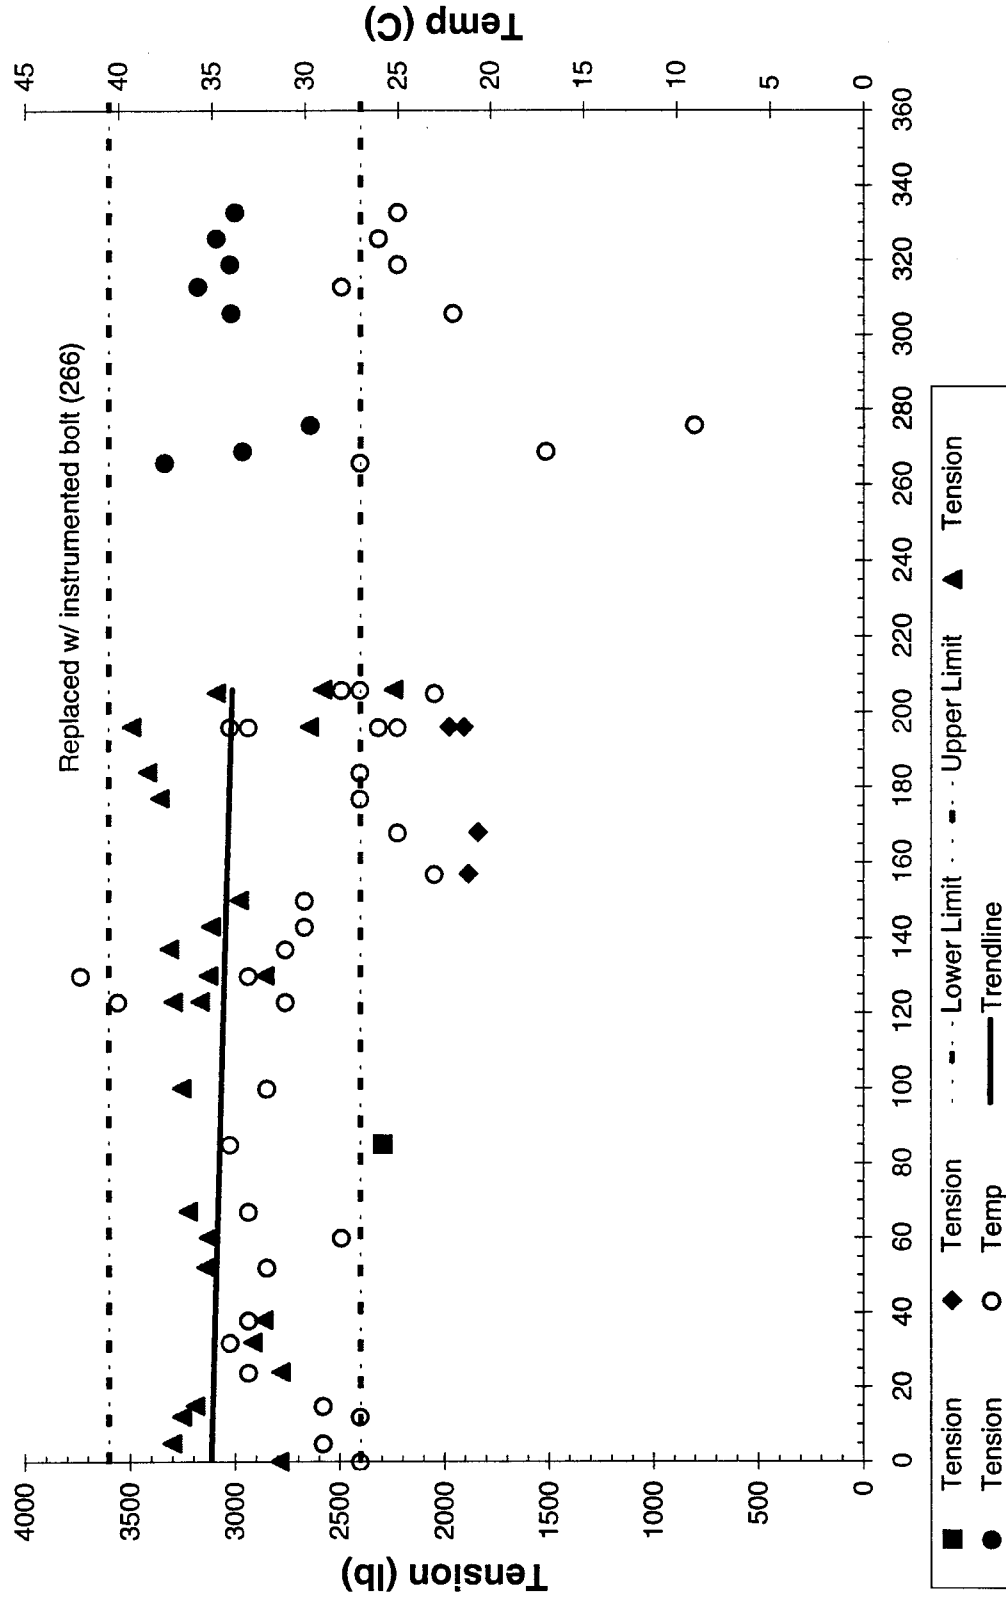
Figure 33 Tension vs Time, Brevard (2) Sign, Bolt with Spring Washers

The spring washers were able to hold the tension within the acceptable range from May 16, 1998 through November 20, 1998 except for two days: October 23 at 1883 lb. and November 4 at 1838 lb. These readings might have been affected by the drop in temperature in those days.

Consequently, multiple readings were done for two days to test whether the temperature had any effects on the strain gages. The readings taken on those two days, December 2 and 11, seemed to indicate that the tension varied with the temperature. However, temperature tests performed in the lab indicated that the temperature should have no effect on the strain gages. Thus, it was concluded that the gages or the adhesive might have some defects. The bolt was removed and brought back to be re-instrumented on January 25, 1999.

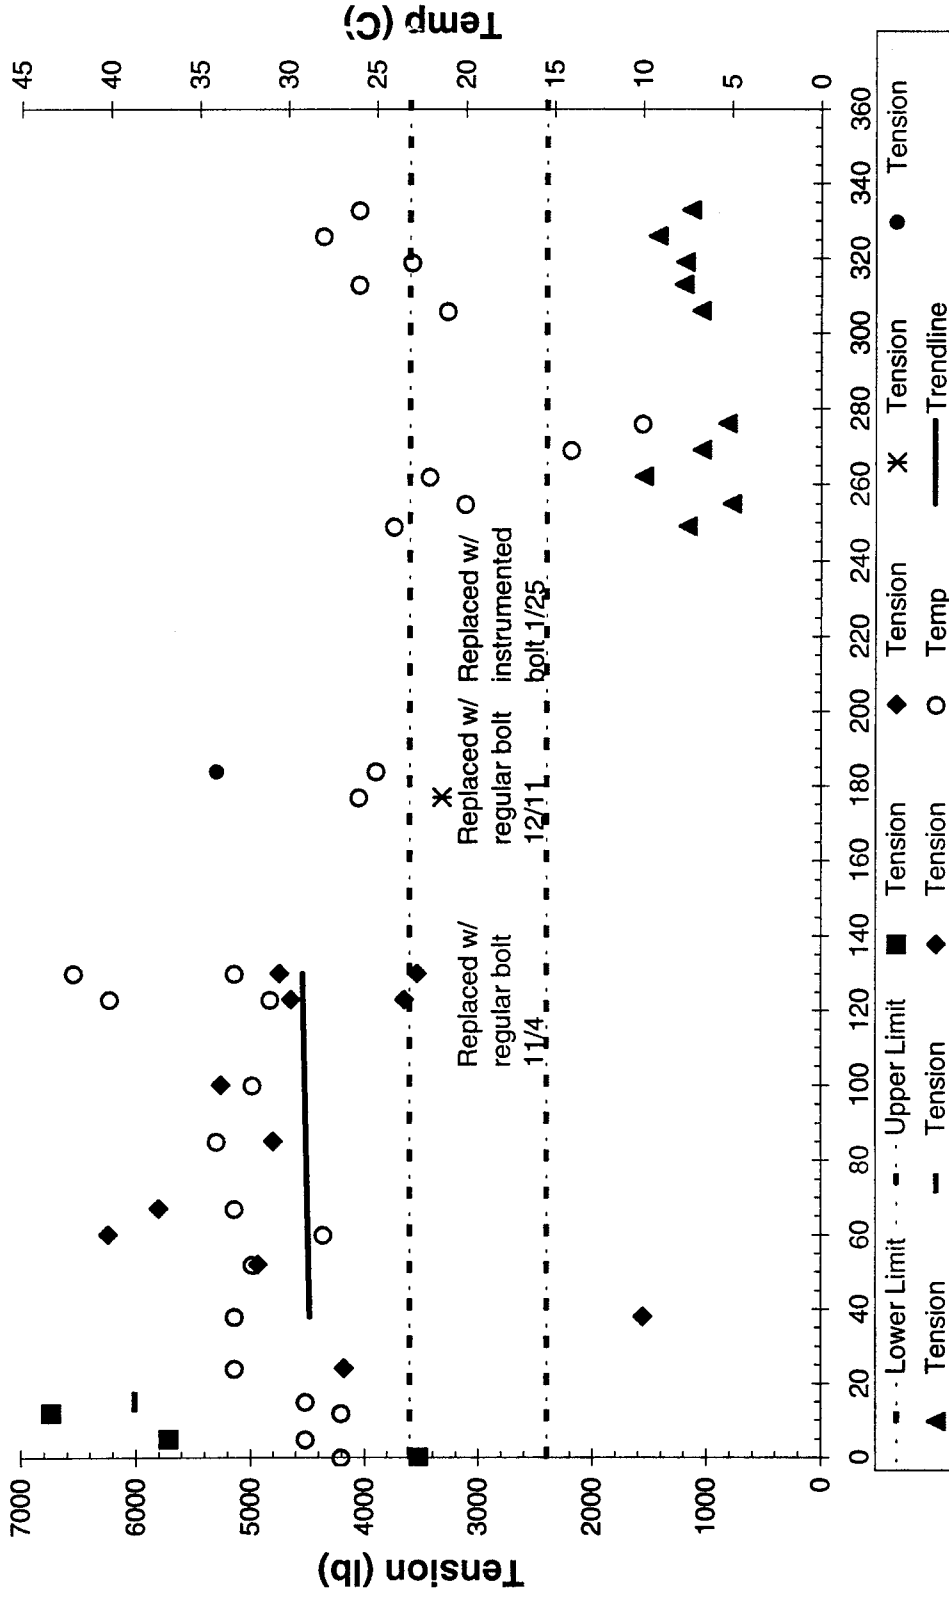
Figure 34 Tension vs Time, Brevard (2) Sign, Bolt with Flat Washers

From October 3 to October 23, 1998, the right gage registered and infinite resistance on the Strain Gage Tester which meant that it was disconnected. The bolt was removed on November 3 and was re-installed on November 13 with a measured modulus of elasticity of 28,112 ksi. After that date, the readings increased dramatically to 11060 lb. and 26565 lb. on December 2, 1998. The bolt was replaced and re-installed on January 25, 1999 with a modulus of elasticity of 28,112 ksi. The reading on that day was low at 1165 lb. The following reading on February 1 was even lower at 777 lb. The bolt was re-torqued using a new torque wrench on February 8. The readings have been decreasing until April 19, 1999, when the readings were discontinued. A tensile test in the lab showed a value of 28,115 ksi for the modulus of elasticity, with no change from the value measured before installation in the field. The gage was then judged to be sound.

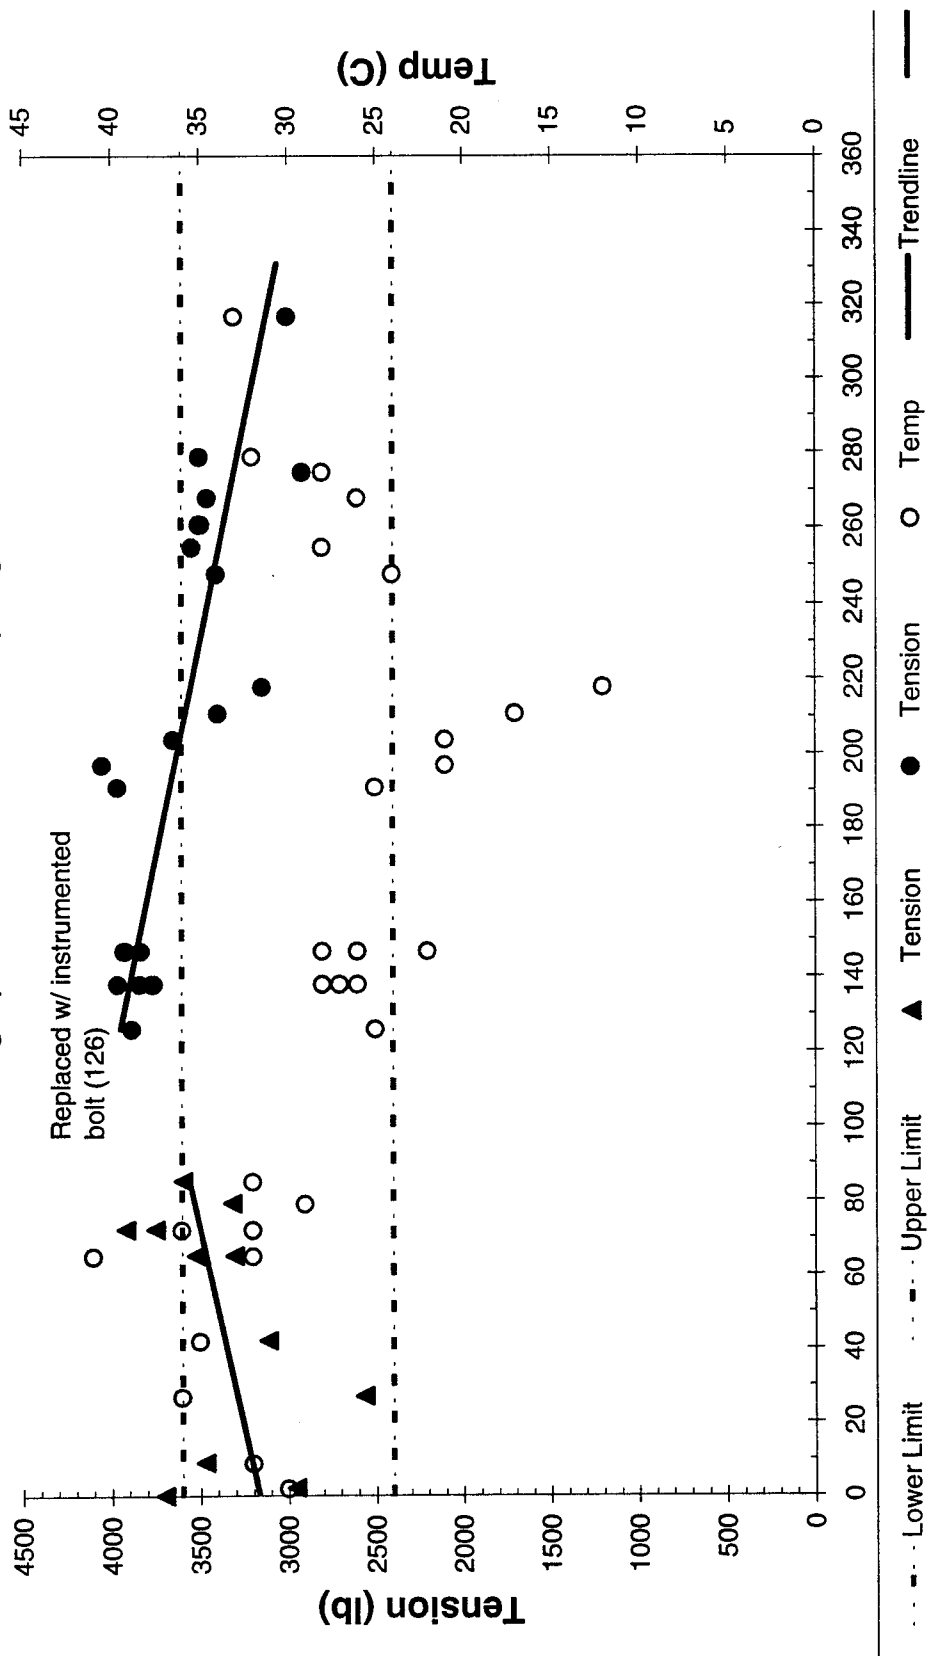
Figure 36 Tension vs Time, Brevard (1) Sign, Bolt with Spring Washers

The bolt with spring washers remained in the acceptable range from July 1998 to November 1998 except for one day: September 26 at 3915 lb. and 3749 lb.

The bolt was replaced on November 4, 1998 because the right strain gage became loose. The newly re-instrumented bolt was re-installed on November 20, 1998 along with a new spring washer stack. After that date, the readings were initially above the upper limit of 3600 lb. until February 15, 1999. From then on, the readings were in the allowable range. On June 15, 1999, the wires were found cut. Therefore the readings were interrupted.

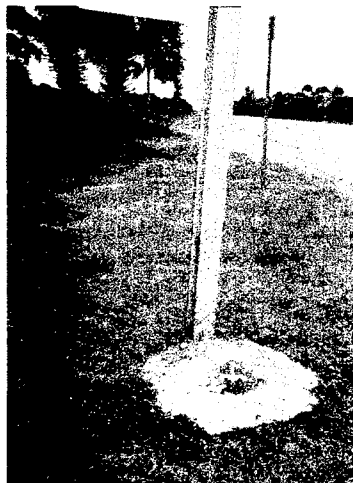
Figure 39 Sebastian Sign after it was hit by a car, 1st view

The post with the bolt with spring washers was found dislodged on December 9, 1998. It was hit by a car and the base connection of the post broke away. Neither the bolts nor the spring washers were damaged and they were found scattered on the ground. Figures 39 and 40 show

the sign after it was hit by a car. This event, totally unexpected, provided a clear demonstration of the effectiveness of the spring washers. The post separated neatly from the base and as far as we know, no major damage was reported for the car. The sign was re-installed afterwards and since then, the readings were initially within the acceptable range. However the last readings are not reliable, because the bolt was not galvanized. The bolt deteriorated very quickly, and became completely corroded.

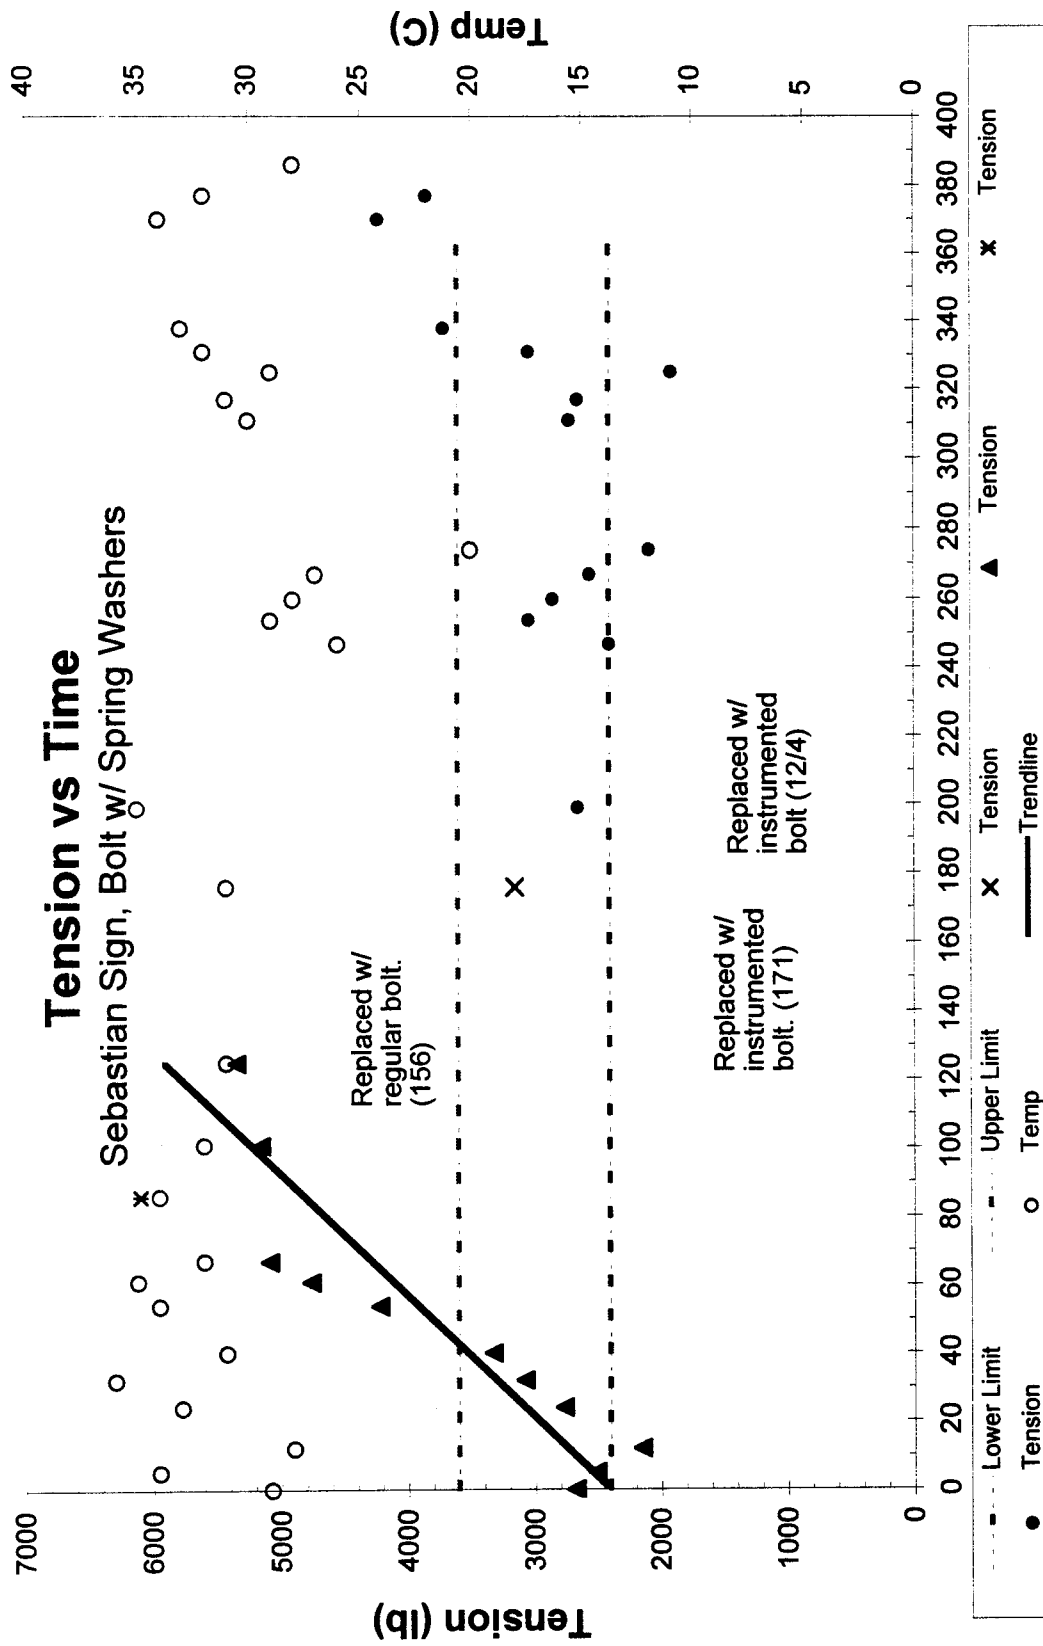
Figure 41 Tension vs Time, Sebastian Inlet Sign, Bolt with Spring Washers

The Sebastian Inlet bolt with spring washers was able to maintain the tension within the acceptable range until June 25 with only one reading dipping below the lower limit; on May 27, 1998 at 2146 lb. After that date the tension readings until September 20 were above the upper limit, peaking at 6098 lb. on August 11, 1998.

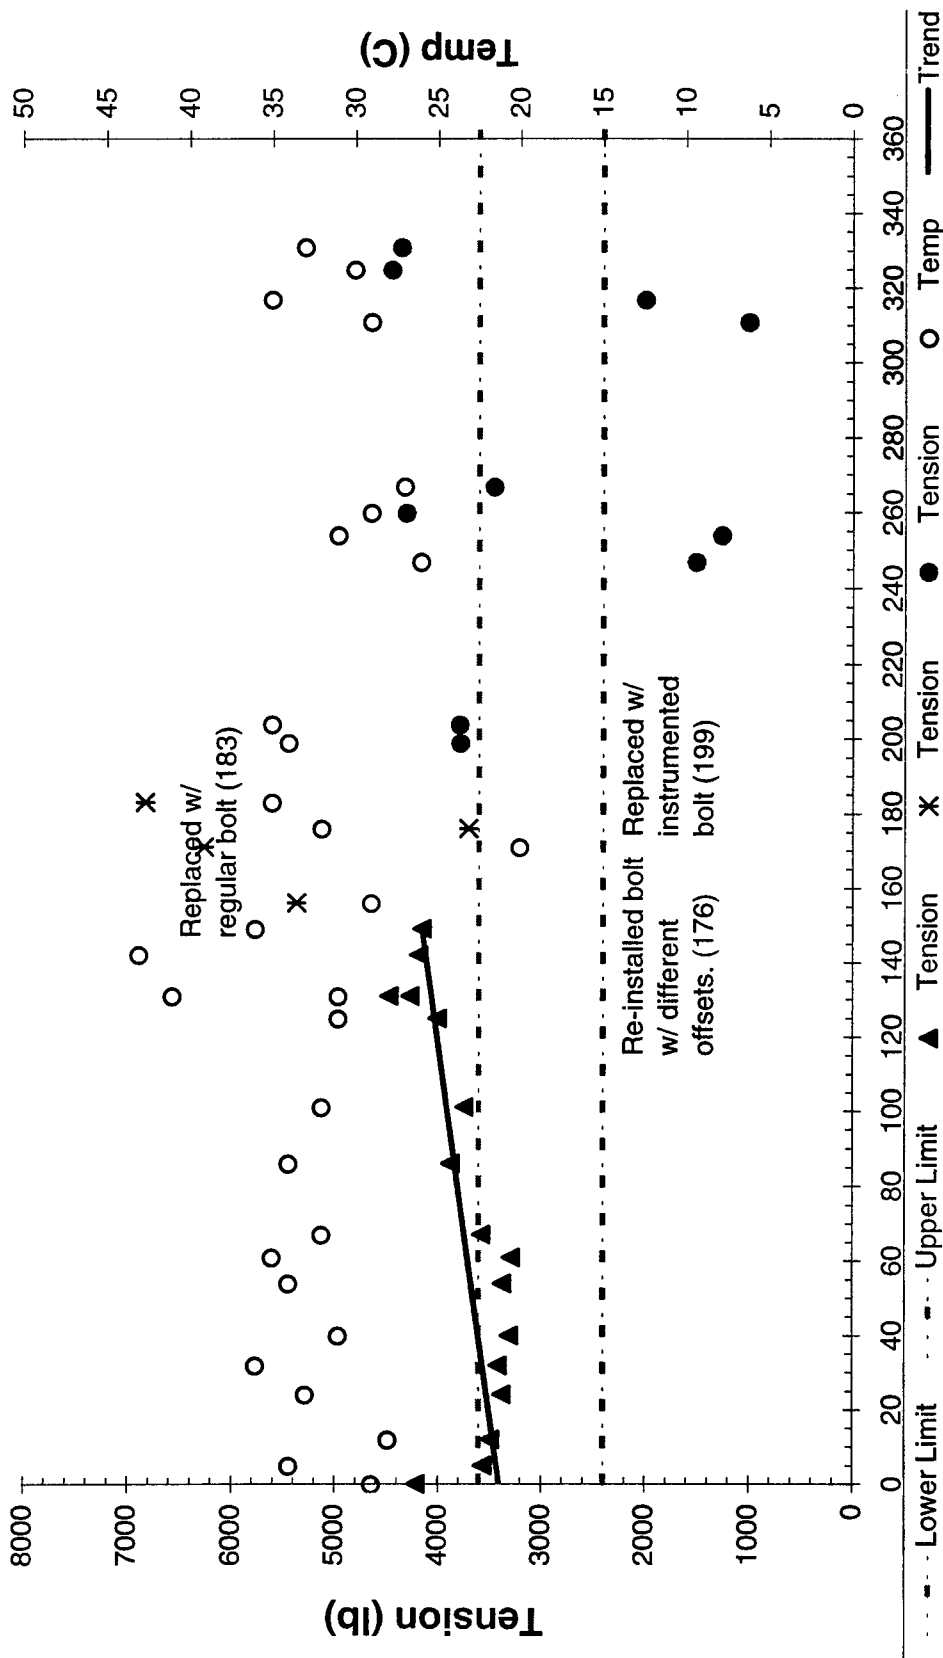
Figure 42 Tension vs Time, Sebastian Inlet Sign, Bolt with Flat Washers

The bolt with flat washers was able to maintain the tension within the acceptable range until July 22. From September 11 to November 6, the readings were above 3600 lb. and the bolt started to

It was suspected that the torque wrench being used may have been inaccurate. A new torque wrench was bought and it was used to re-torque the bolt on February 5, 1999. That day's reading was high at 4300 lb. but went down to 3449 lb. on February 12. No readings were taken on February 19 because the readings were negative numbers in the thousands range. The gages were probably damaged. Subsequent readings were either below or above the allowable range. The bolt was finally removed and brought back to the lab. A tensile test showed a value of 29,276 ksi for the modulus of elasticity. Consequently, the erratic behavior of the bolt could not be attributed directly to a defect of the strain gages.

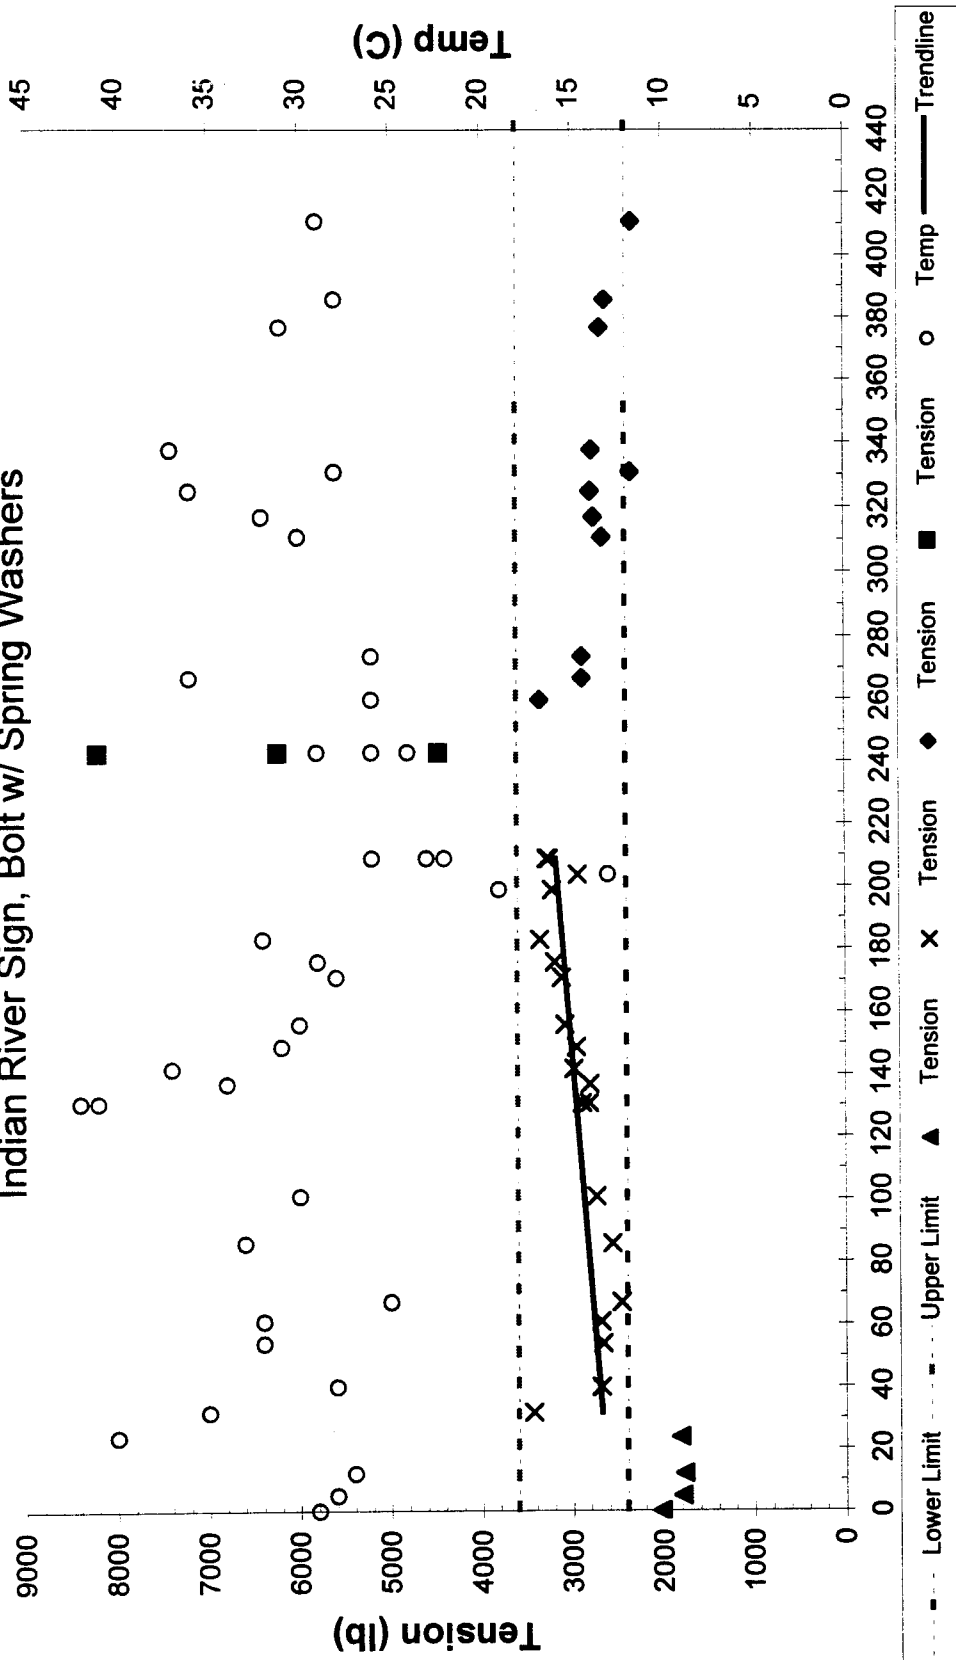
Figure 44 Tension vs Time, Indian River Sign, Bolt with Spring Washers

For the Indian River bolt with spring washers, the readings from May 15, 1998 through June 9, 1998 were all under the lower limit of 2400 lb. The bolt was then re-installed and it maintained the tension within the acceptable range (2400 lb. to 3600 lb.) from June 1998 through early December 1998. From June 17, 1998 through January 18, 1999 the left strain gage read a negative strain indicating that the bolt was subjected to a combination of tension and bending. This is reflected in the big eccentricities in the readings.

The initial readings taken during January 1999 showed that the tension increased, so we brought the bolt back to have the strain gages replaced. After replacing the strain gages, the spring washers were able to maintain the tension within the acceptable range until this date.

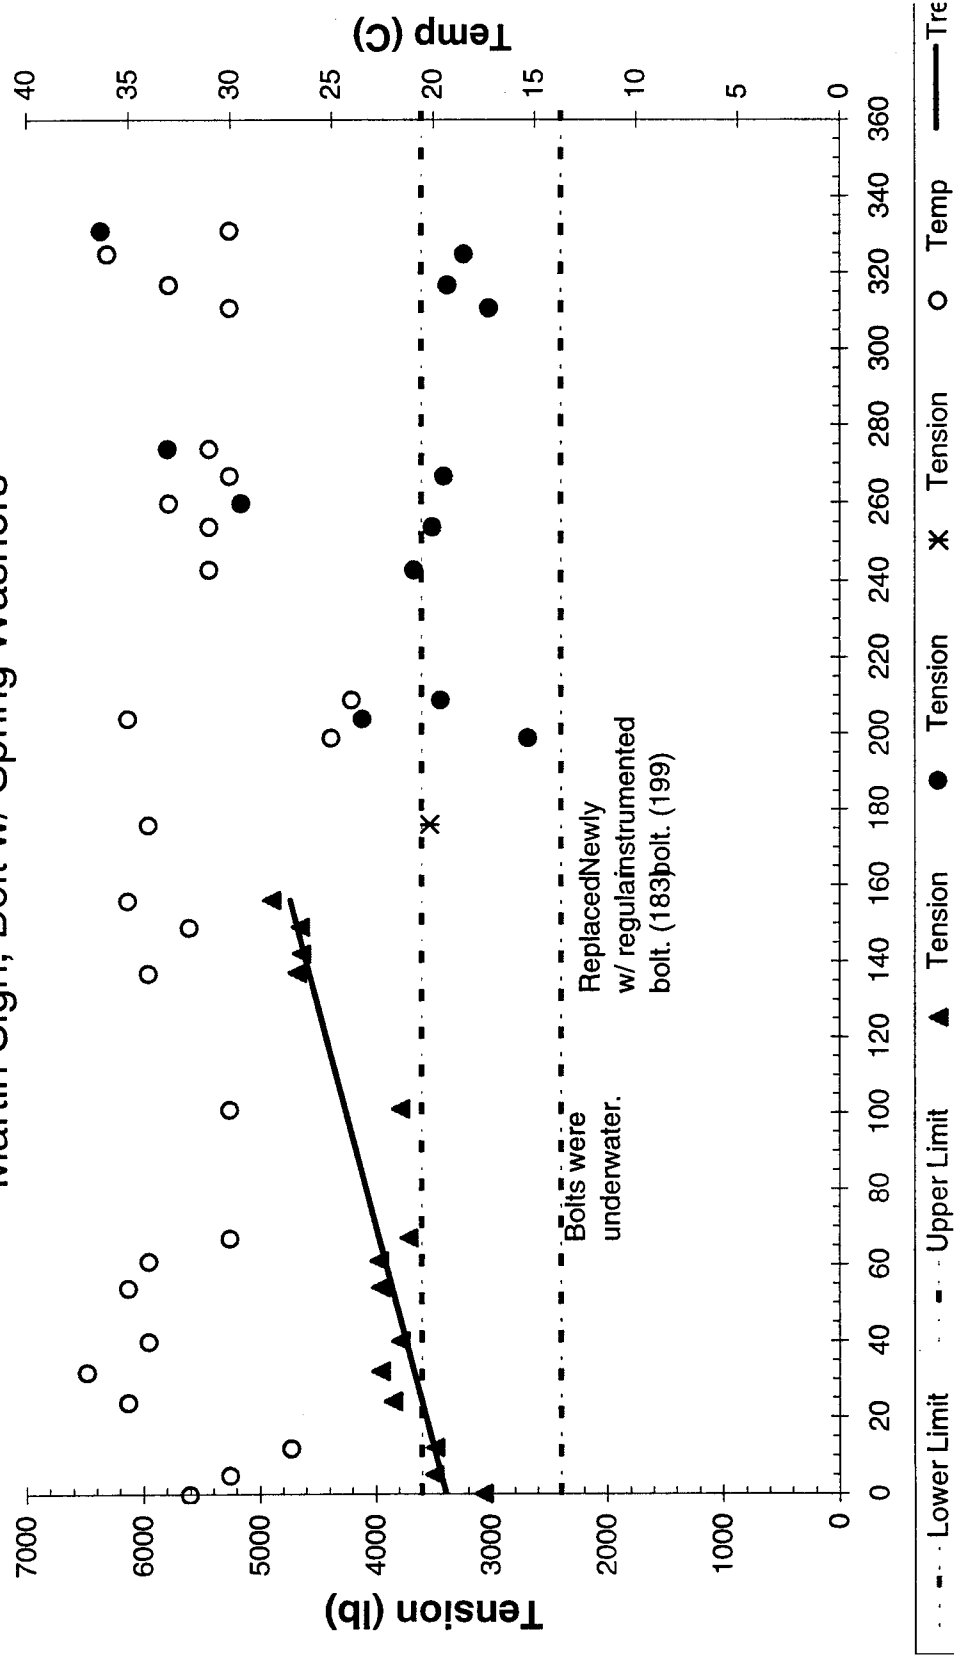
Figure 47 Tension vs Time, Martin County Sign, Bolt with Spring Washers

The Martin County bolt with spring washers was able to maintain the tension close to the acceptable range until August 8. It was submerged under water for at least a day on August 11 after which on August 26, the tension reading was 3786 lb. It was again submerged under water on September 10, 1998. From October 2 to October 21, 1998, the tension readings ranged from 4638 lb. to 4894 lb. Again, the bolt was submerged in water on November 6, 1998.
